MOHAWK RIVER BASIN  
CITY OF GLOVERSVILLE  
FULTON COUNTY, NEW YORK

# WEST MILLPOND DAM

## NY 01060

PHASE I INSPECTION REPORT  
NATIONAL DAM INSPECTION PROGRAM

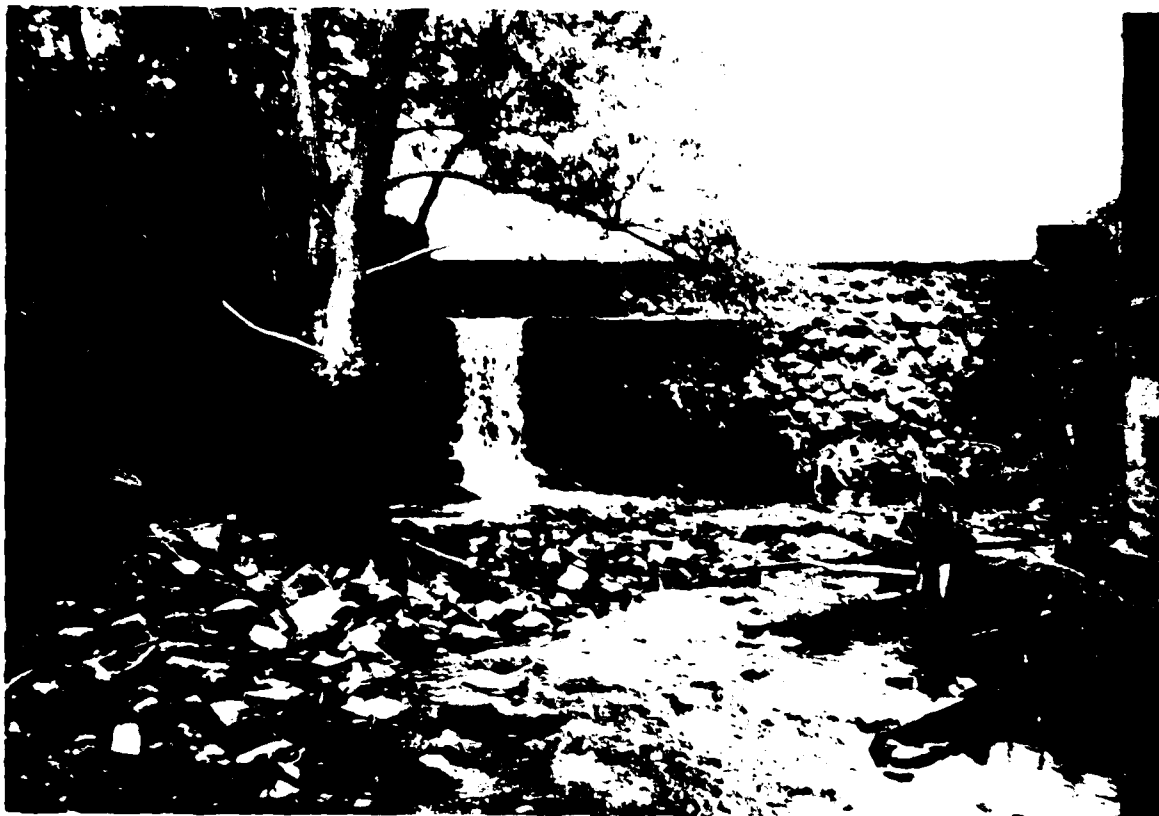
Overview Photo - West Millpond Dam ( spillway ) - 6 3 81

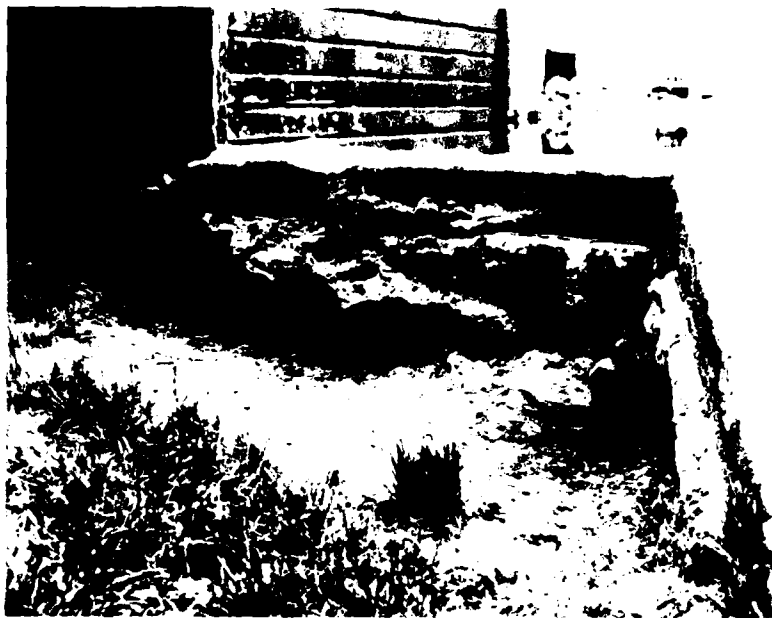
A-3A Apparent erosion or lost ground on downstream side of upstream retaining wall next to right side of spillway - 6/3/81

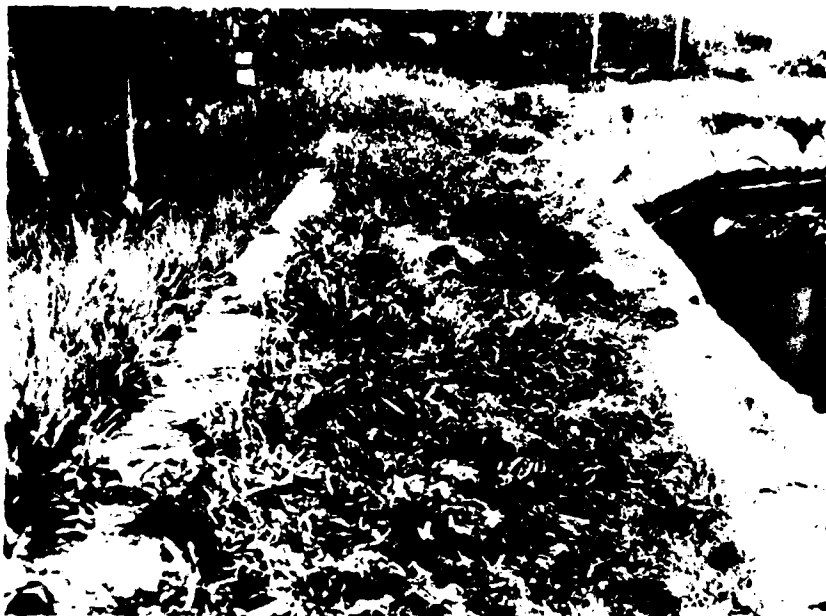
Crest - The crest of the dam is covered with grass over much of its length (see Photo A-2A), but there is a section near the left abutment which is covered with sand and is practically bare of vegetation (see Photo A-2B). There is an irregular depression on the crest, about one foot deep and 5 feet in diameter, 30 feet left of the spillway. There are also depressions along the upstream side of the crest next to both the right (see Photo A-3A) and left (see Photo A-3B) sides of the spillway. The apparent remains of a foundation wall for an ice house are visible on the crest of the embankment to the right of the spillway (see Photo A-4A).

A-4A Top of dam viewed from right side of gate house. Concrete-faced masonry retaining wall is on upstream side of crest and old foundation wall is downstream of crest - 6/3/81

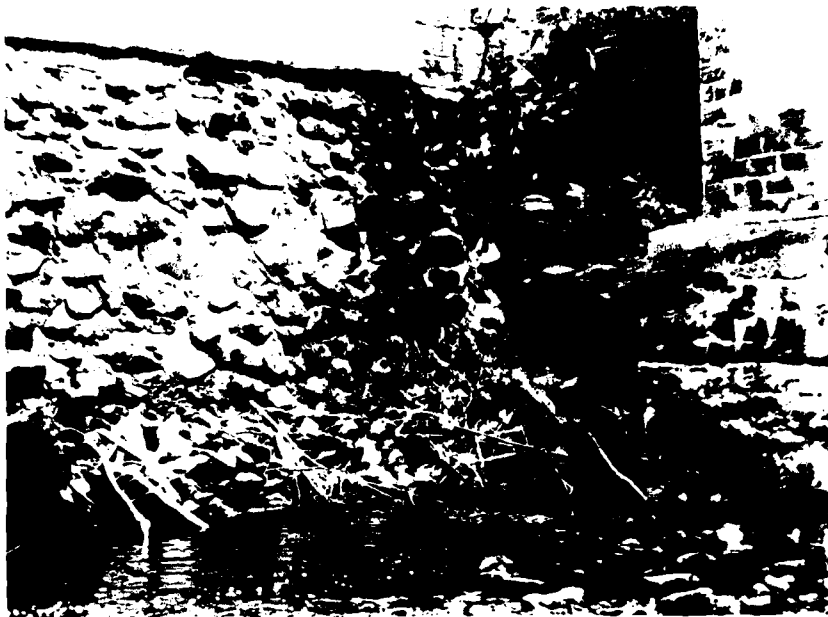
A-5A Downstream face of spillway and dam at left side of downstream channel - 6/3/81

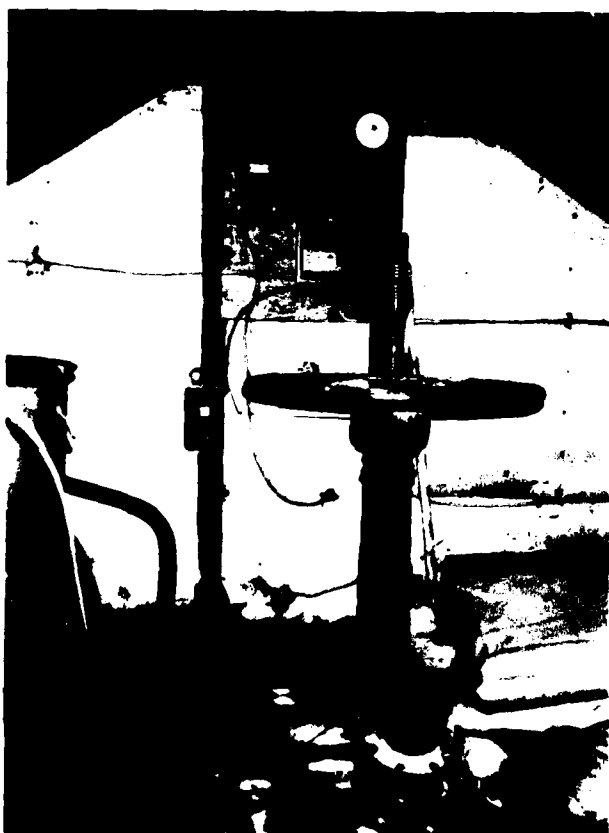
The 18-inch-diameter cast iron water supply main supplies process water to the Owner's plant. The condition of this pipe was not observable. The floor stand control for the valve on the supply main is rusted, but operable and well lubricated.

A-8B Rising-stem floor stand with hand-wheel in gate house for water supply main. Lever control for outlet pipe is to left of floor stand and beyond right side of photo - 6-3/81
